R 197

COATING STUDIES AT KWAJALEIN,
KANEHOE, AND PORT HUENEME

2 July 1962

OBJECT OF TASK

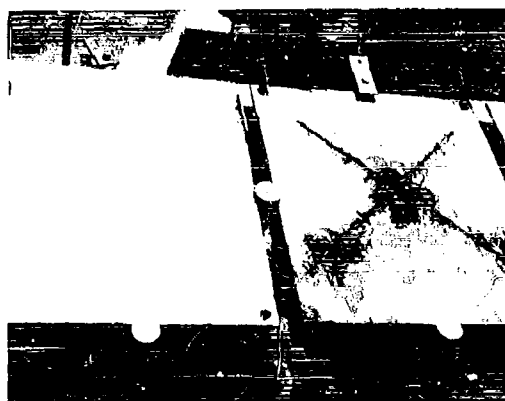
Kwajalein, 4-1/2 years

On the scribed panels this system failed at Kwajalein after 4-1/2 years as a result of blistering and rusting and was removed from test. The degree of blistering at the scribe was rated 2/M at Kaneohe after 5 years and 2/F at Port Hueneme after 5-1/2 years; protection was rated 8 and 10, respectively. Light rusting was occurring in the scribed mark at these two test sites.

The unscribed panels, after 5 years at the three test sites, have received very good protection, except at mechanical breaks or pinholes which exposed the steel substrate. Also slight rusting and blistering, aggravated to some extent by edge effects, has occurred at the corners and sides of the test panels that remain on exposure. The over-all rating for the unscribed panel at each test site was 9 at Kwajalein and Kaneohe and 10 at Port Hueneme.

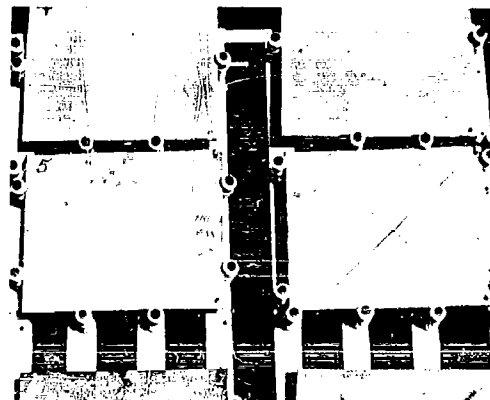
Port Hueneme, 5-1/2 years

This vinyl system failed because of blistering and rusting along the scribed mark at Kwajalein after 4-1/2 years and was removed from test. The scribed panel at Kaneohe has only a few blisters (2/F) and light rusting after 5 years, and the scribed panel at Port Hueneme has no blisters after 5-1/2 years.

The unscribed panel at Kaneohe after 5 years and at Port Hueneme after 5-1/2 years was rated 10; the unscribed panel at Kwajalein was rated 9 after 4-1/2 years. The first signs of failure on the unscribed panel at Kaneohe and Port Hueneme were found at edges and corners. Coating breakdown has also occurred at pinhole breaks in the coating.

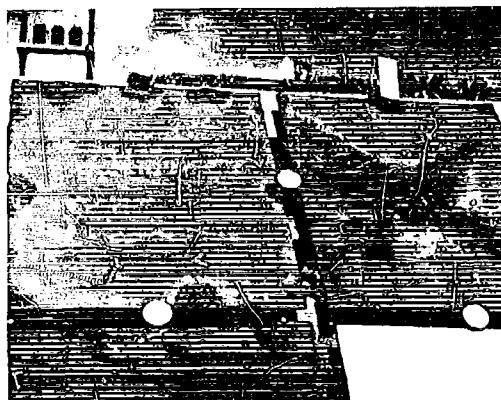
Kwajalein, 4-1/2 years

The vinyl mastic failed along the scribed mark, after 4-1/2 years at Kwajalein, because of blistering and was removed from test. Only a few blisters (rated 2/F) had appeared along the scribed mark at Kaneohe after 5 years, and no blistering was present after 5-1/2 years at Port Hueneme.

The unscribed panel was rated 9 after 5-1/2 years at Kwajalein. Failure started with the formation of blisters and rusting at corners and edges. The unscribed panel was rated 10 after 5 years at Kaneohe and 5-1/2 years at Port Hueneme. Only very slight evidence of weathering was found at the edges and corners of these panels.

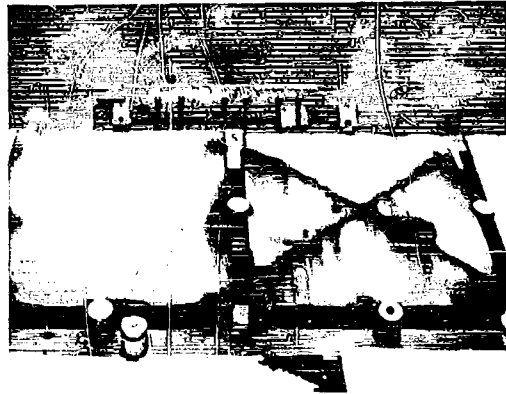
Kwajalein, 5-1/2 years

The blistering of this coating at the scribed mark was rated 2/MD after 5-1/2 years exposure at Kwajalein. Although heavy rusting along the scribed mark was causing discoloration of the paint film, the over-all protection given by this coating was rated 7. After 5 years at Kaneohe, rusting along the scribed mark was light, and blistering was rated 2/F. At Port Hueneme, no blistering had occurred along the scribe after 5-1/2 years.

The protection given to the un-scribed panel was rated 8 at Kwajalein, 9 at Kaneohe, and 10 at Port Hueneme. Failure of the coating on the unscribed panels has proceeded from the corners and edges.

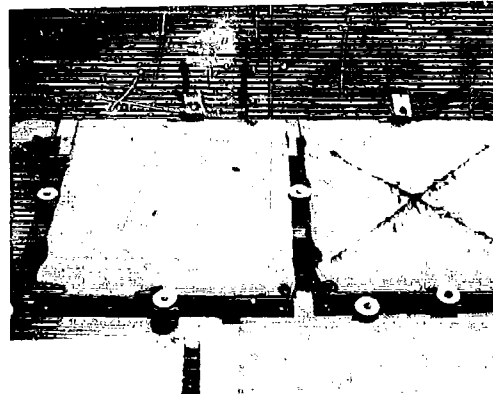
Kwajalein, 5-1/2 years

Blistering, rated 2/MD, and considerable rusting have occurred along the scribed mark, during 5-1/2 years at Kwajalein and 5 years at Kaneohe. However, the over-all protection was rated 7. No blistering has occurred along the scribed mark after 5-1/2 years at Port Hueneme.

Initial attack by blistering and rusting has occurred at the corners and edges of the unscribed panels at Kwajalein and Kaneohe, and the panels were rated 9. The panel at Port Hueneme was rated 10.

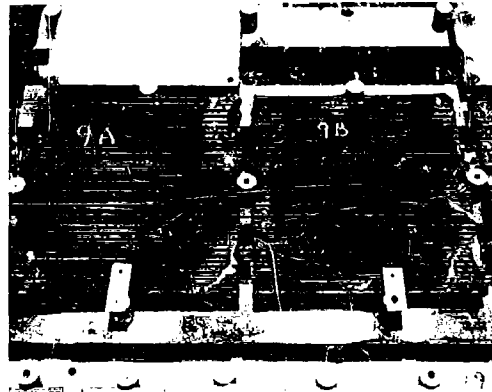
Kwajalein, 5-1/2 years

The blistering along the scribed mark was rated 2/D after 5-1/2 years at Kwajalein and was aggravated by slight undercutting. This failure had not progressed outward from the scribed mark to any extent, but because of rusting, blistering, and undercutting at the corners and edges, the over-all rating was 6, and the panel was removed from exposure. The scribed panel at Kaneohe after 5 years was rated 2/M on blistering along the scribed mark, and 9 on over-all protection. After 5-1/2 years at Port Hueneme, it was rated 10.

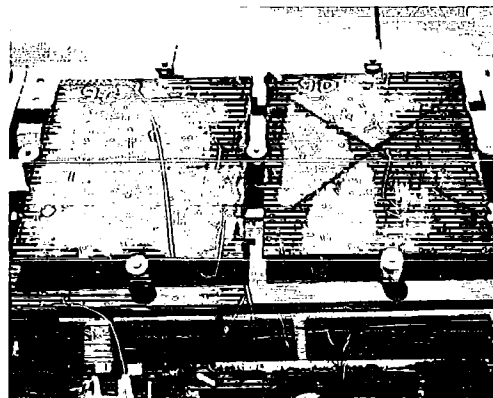
Kaneohe, 5 years

Light checking covered the surface of the neoprene at Kaneohe and Port Hueneme. This checking was not observed at Kwajalein.

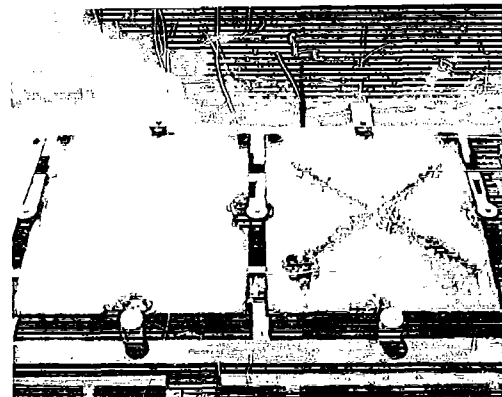
Kaneohe, 5 years

The chlorinated rubber coating failed completely because of blistering along the scribed mark, after 3 years at Kwajalein, and was removed from test. The blistering of the scribed panel, after 5 years at Kaneohe, was rated 2/D, and the protection given to the test panel was rated 7. After 5-1/2 years at Port Hueneme, no blistering had occurred.

On the unscribed panel at Kaneohe, blistering was occurring at points where slight pressure was applied by the porcelain insulators. The over-all rating was 9 at Kaneohe and 10 at Port Hueneme. The panel at Kwajalein was lost after three years of exposure, at which time the rating was 9.

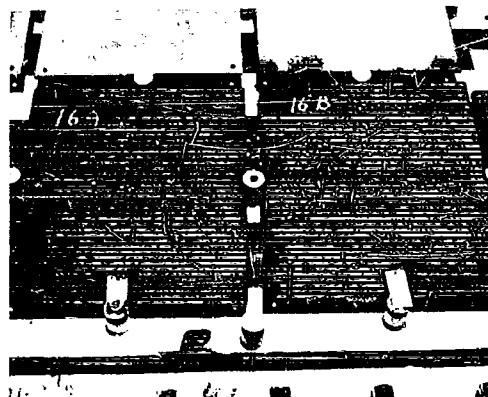
Kwajalein, 5-1/2 years

The general appearance of this coating was good, and the protection being given to both the scribed and unscribed test panels after 5 years exposure at Kaneohe and 5-1/2 years at Kwajalein and Port Hueneme was rated 10. Very light rusting had appeared in the scribed marks, but no blistering had occurred.

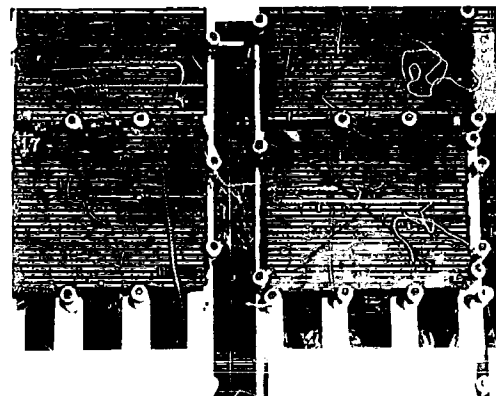
Port Hueneme, 5-1/2 years

The scribed panel was removed from exposure after 4-1/2 years at Kwajalein. Blistering along the scribed mark and edges was rated 2/MD and more than 40 percent of the panel surface showed rusting and blistering. At Port Hueneme, after 5-1/2 years, the scribed panel was rated 10. At Kaneohe, after 5 years, the protection rating was 9 and blistering was rated 2/F.

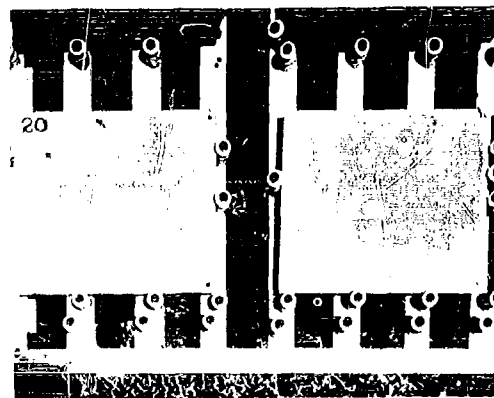
Port Hueneme, 5-1/2 years

At Kwajalein, the protection after 2 years was rated 0, and the panels were removed from test. At Kaneohe after 5 years, the protection was rated 9 (edge-rusting), and at Port Hueneme, after 5-1/2 years, the rating was 10. No rusting was observed along the scribed mark at either Kaneohe or Port Hueneme.

Zinc salts were present over most of the surface of the test panels.

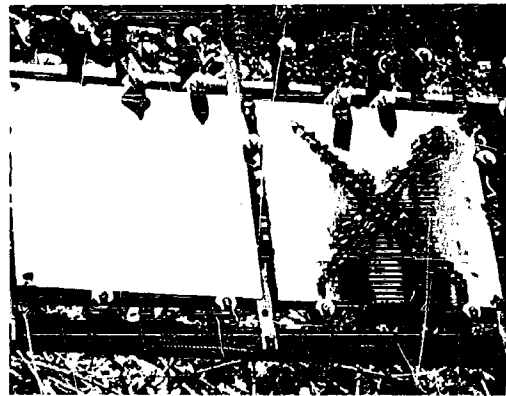
Kwajalein, 3 years

The scribed panel coated with Saran failed after 3 years at Kwajalein because of blistering along the scribed mark. At Kaneohe after 5 years, blistering along the scribed mark and edges was rated 2/MD, and at Port Hueneme after 5-1/2 years, the blistering was rated 4/M.

The protection to the unscribed panel at Kwajalein after 5-1/2 years was rated 8 because of slight blistering at edges and pinhole rusting over the surface. No blistering had occurred on the unscribed panel at Kaneohe; but many very small pinhole rust spots were present, and the panel protection was rated 9. At Port Hueneme, the panel was rated 10 after 5-1/2 years.

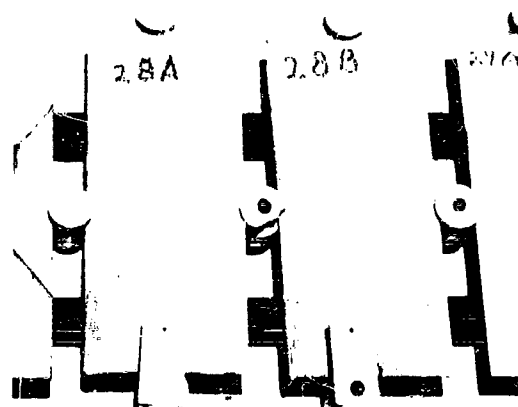
Kwajalein, 2-1/2 years

After 2-1/2 years at Kwajalein, white zinc salts had formed over about 10 percent of the surface; however, no rusting had occurred along the scribed mark or on the unscribed surface and the overall protection was rated 10. Zinc salts had formed at minute blisters; blistering over the surface of the two panels was rated 8/M.

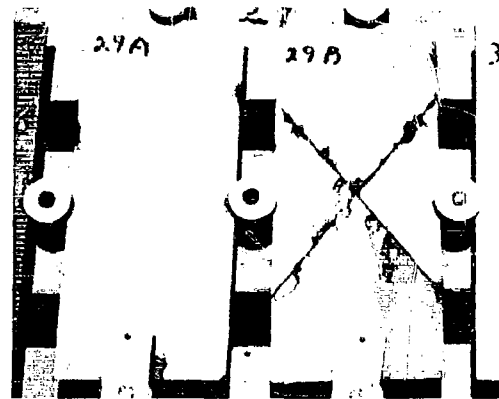
Kwajalein, 2-1/2 years

After 2-1/2 years at Kwajalein, there was blistering along the scribed mark, and the coating was rated 2/D. At Kaneohe after 2-1/2 years, blistering of the scribed panel was rated 4/F. No blistering or rusting had occurred after 2-1/2 years at Port Hueneme, and the coating on the scribed panel was rated 10.

The protection to the unscribed panels was rated 9 at Kwajalein and 10 at Kaneohe and Port Hueneme.

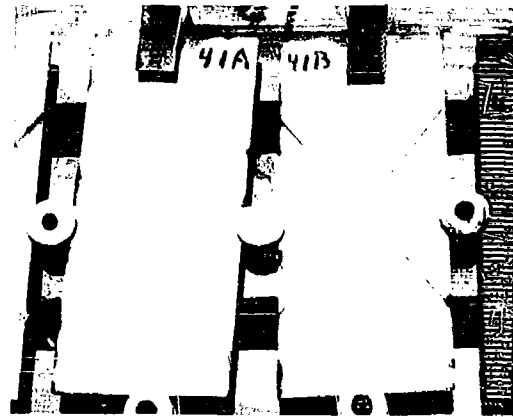
Kwajalein, 1-1/2 years

The protection of the unscribed panel was rated 9 at Kwajalein because of blistering and rusting at the edges; no failure of the coating was observed at Port Hueneme, and the coating was rated 10.

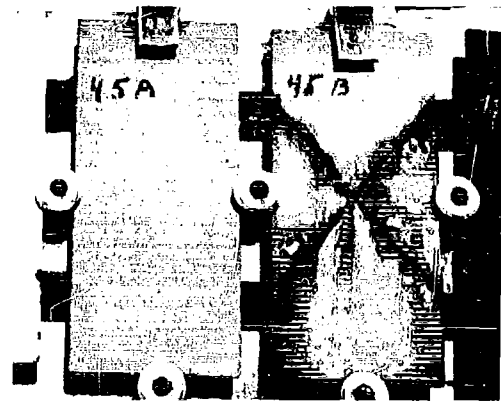
Kwajalein, 1-1/2 years

The scribed panel at Kwajalein after 1-1/2 years had dense blistering along the scribed mark, rated 2/D. There was heavy rusting in the scribed mark, and the overall protection was 7. After 2 years at Port Hueneme no blistering had occurred, and this panel was rated 10.

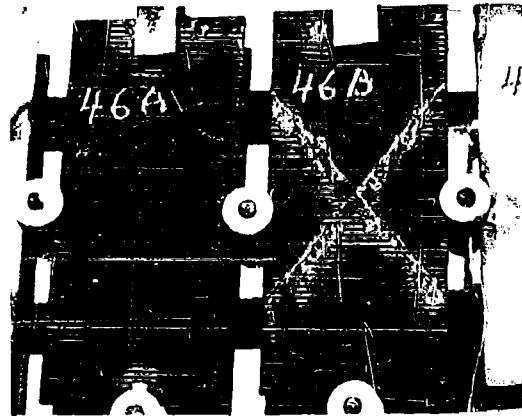
Kwajalein, 1-1/2 years

After 1-1/2 years at Kwajalein a urethane tar (System 46) had failed to the same degree at the scribed mark as had the epoxy tar (System 100) after 3 years at this test site.

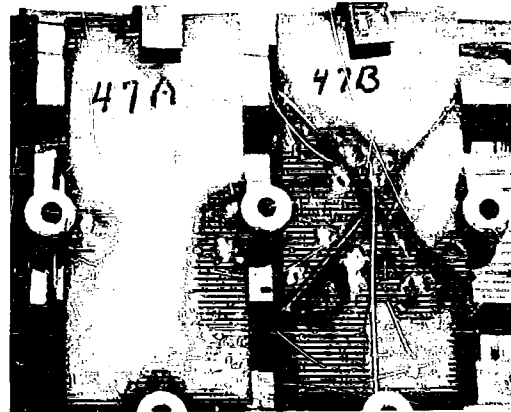
Kwajalein, 1-1/2 years

The scribed panel at Kwajalein failed after 1-1/2 years and at Port Hueneme after 2 years and was removed from test. Blistering at Kwajalein was rated 2/D. At Port Hueneme there was no blistering but the coating flaked over 50 percent of the surface of the panel.

The unscribed panel at Port Hueneme had received excellent protection, rated 10; the panel at Kwajalein had blistered and rusted at the edges and was rated 8.

This coating was applied directly over a wash primer. This type of primer does not appear suitable for urethane.
